No.: SI-TB2023072101

From: Technical Team, MG Motor Europe

Subject: Left curtain airbag resistance low repair

Vehicle Platform: MG4

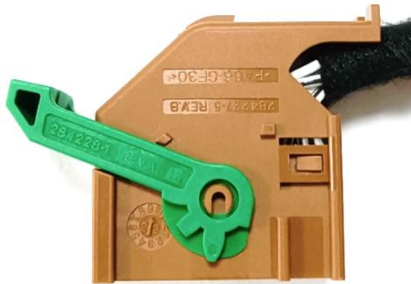
1. Following the repair manual to remove the connector of SDM(BY068)

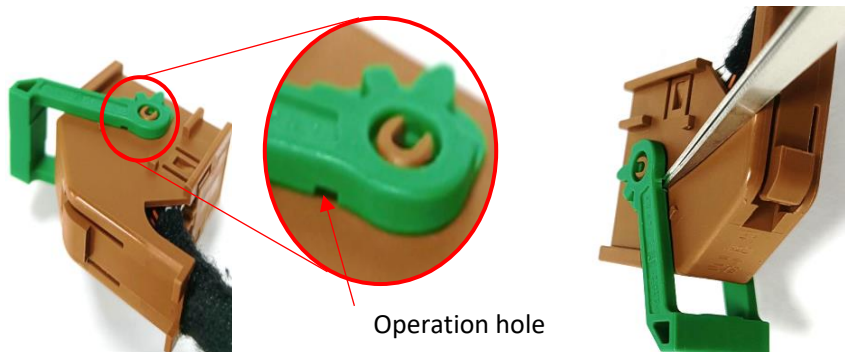
2. Separate the green lever from cover hinge on both sides.

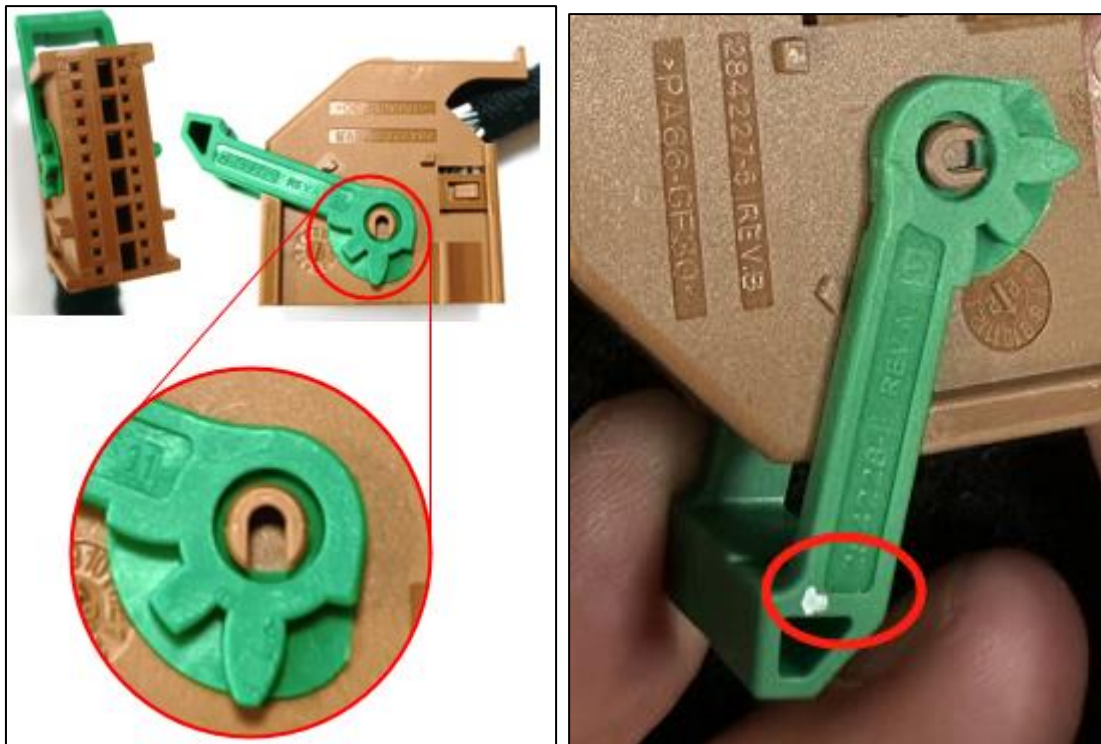
3. Install the new lever on the brown connector.

Note: It is hard to distinguish the new one with the old one by shape or size, there is white paint on the new lever.
