Technical Information: TI-20231228

Subject: EH32 (MG4) – Subframe lower guard to battery gap - CEE

Vehicle Platform: MG4

Version: V 1.0

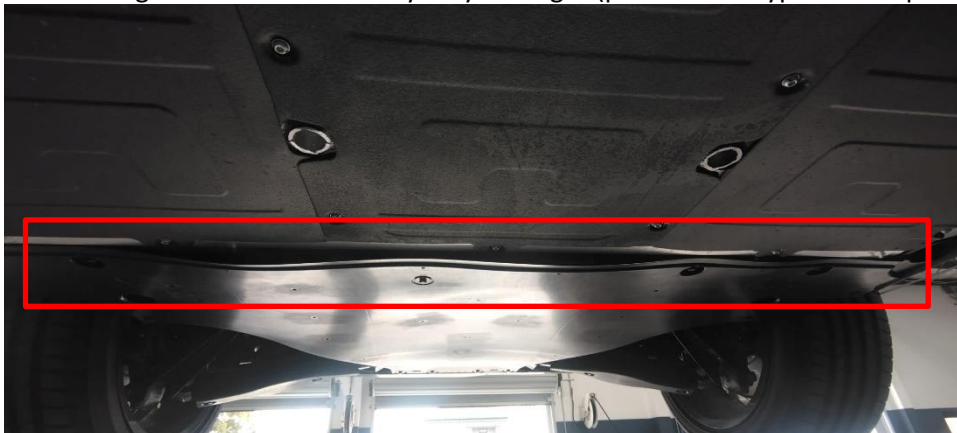
This Technical Information is about a recent product enhancement. After long time driving, the gap between the rear subframe lower guard to the HV battery may be larger (please see a typical example below).

In order to solve the issue of EH32 rear subframe lower guard and battery gap, the following aftersales aluminium alloy bracket (P/N. 11769392) is added, which is externally mounted on the rear subframe lower guard to control the gap. Meanwhile, 2 new long fastening bolts (P/N.90006778) are added to replace the original bolts.
